# Technical News Bulletin

Steinhausen, August 2015

## FPS Valve Tester and FPS Valve Repair

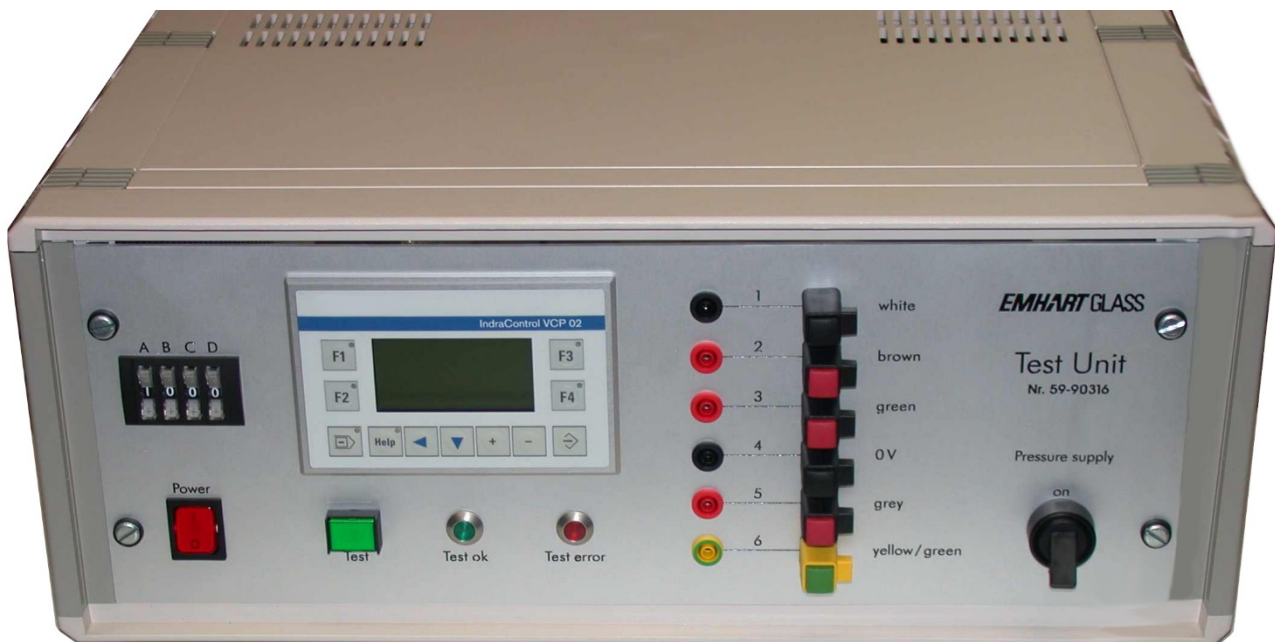
- The Valve Tester will enable customers to make simple repairs of dirty, or worn valves components, and test the performance of these valves before installation.
- The valve tester provides different functional test for FPS valves used for plunger up or counter blow/plunger cooling.
- An initial one cycle test validating the function of the valve and provides a go/no go result with the related error code.

All functions of the FPS valves will be tested according to the type of the valve and according to the application. The valve tester provides different functional test for FPS valves used for plunger up or counter blow/plunger cooling.

Three different test modes are possible:

An initial one cycle test validating the function of the valve and provides a go/no go result with the related error code.

A 1000 cycle test provides the possibility to detect multiple error sources which may occur randomly. The errors are counted during this 1000 cycles and the error code is displayed together with the number of errors.

A third “endless test”, which stops after the first error, which will also be displayed. This test is normally used to verify the performance of a valve after a valve repair.

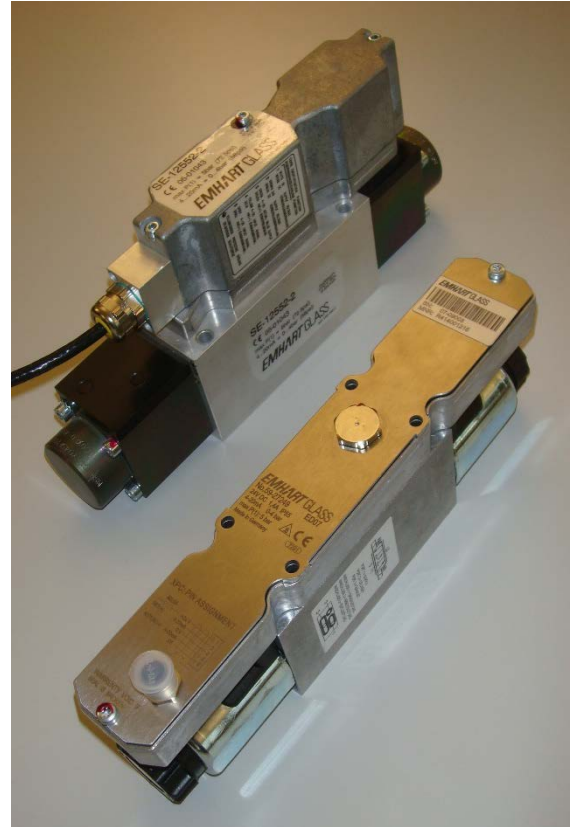
**Repair kit components**

Top left: ND12  
Bottom right: ED07

The valve seats of the proportional valves are subject of wear due to the possible contamination of the valves with residues of swabbing material, oil and even glass particles.

Poorly performing valves are tested with the valve tester to detect the reason for the malfunction. In most cases, faulty operation is caused by leakage of the supply and exhaust cartridges. The leakage of the supply and exhaust cartridge can be eliminated in most cases with the exchange of the valve seats.

This is possible with the help of the fixture. Only the valve seat itself will be exchanged during this procedure. All the other parts in the cartridge remain. The cartridge is mechanically calibrated with shims which contribute to the high precision of the FPS valves. It is important that all the other parts in the cartridge remain unchanged. During the disassembly and the assembly of the valve attention has to be paid to separate the supply and the exhaust cartridge. The two cartridges are different from each other. The supply and exhaust cartridge has to stay in the same valve body as both cartridges are electronically calibrated which is an important factor for the precision and speed of the valve. It is recommended to exchange the O-rings of the cartridge during the repair as well.

After the repair it is required to test the valve again with the valve test to validate if the repair was successful. This procedure offers a cost effective method to increase the lifetime of the valves and keep the high performance levels.

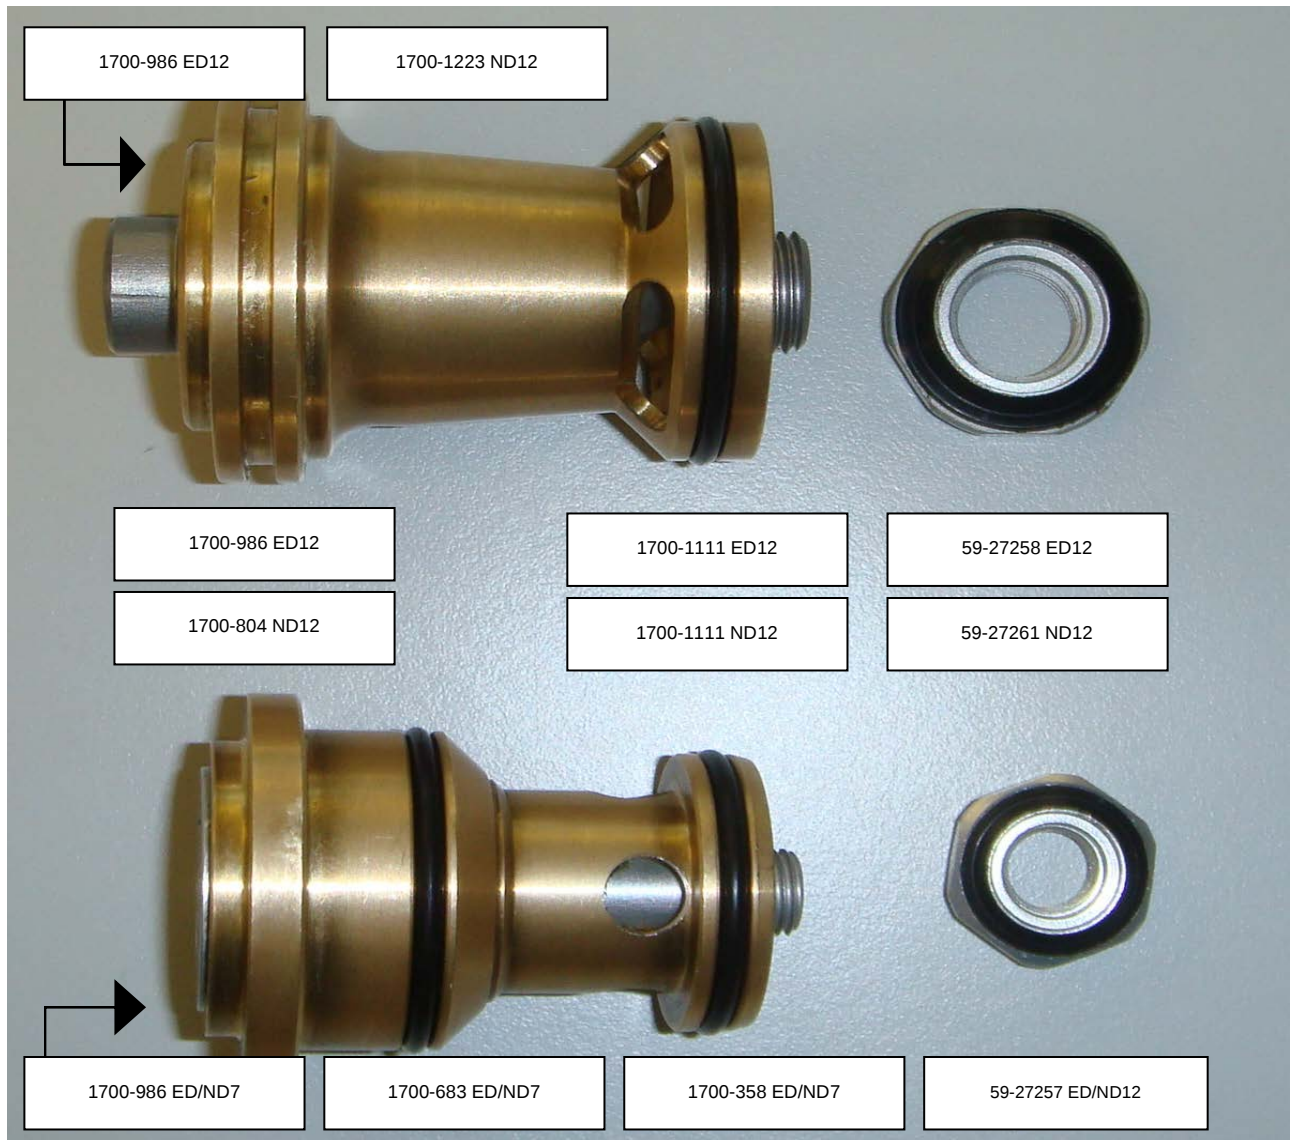
Top: ED12 cartridge and valve seat  
Bottom: ED07 cartridge and valve seat

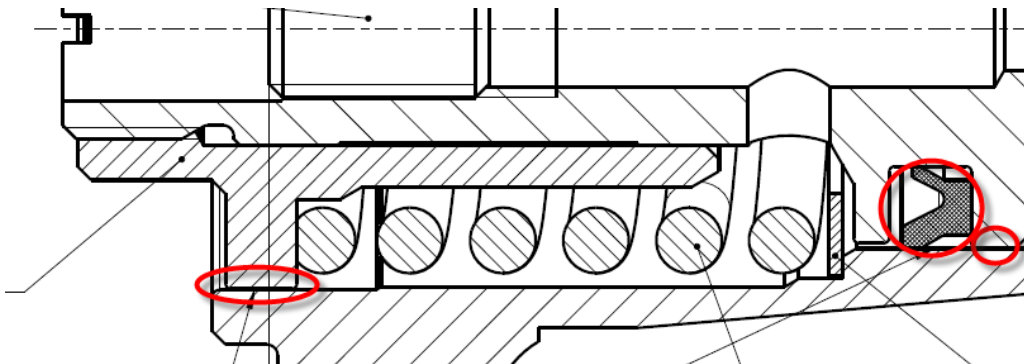
## Grease for Sealing

Tube 20 g, 59-27568

Thickness of grease film approx. 0,2 mm

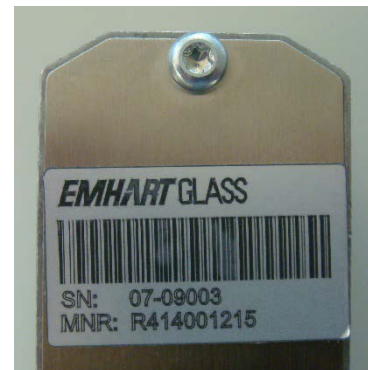
Valves older than 4 years will not be accepted for repair. The manufacturing date can be read for the serial number (SN). The first two digits give the year and next two digits giving the manufacturing month. The valve shown in the picture was produced in September 2007 (07-09XXX).
